Docket No. 217 – Development and Management Plan Inspection

Northeast Utilities Service Company Certificate of Environmental Compatibility and Public Need for the construction of a 345-kV electric transmission line and reconstruction of an existing 115-kV electric transmission line between Connecticut Light and Power Company's Plumtree Substation in Bethel, through the towns of Redding, Weston, and Wilton, and to the Norwalk Substation in Norwalk, Connecticut.

Date: May 25, 2006

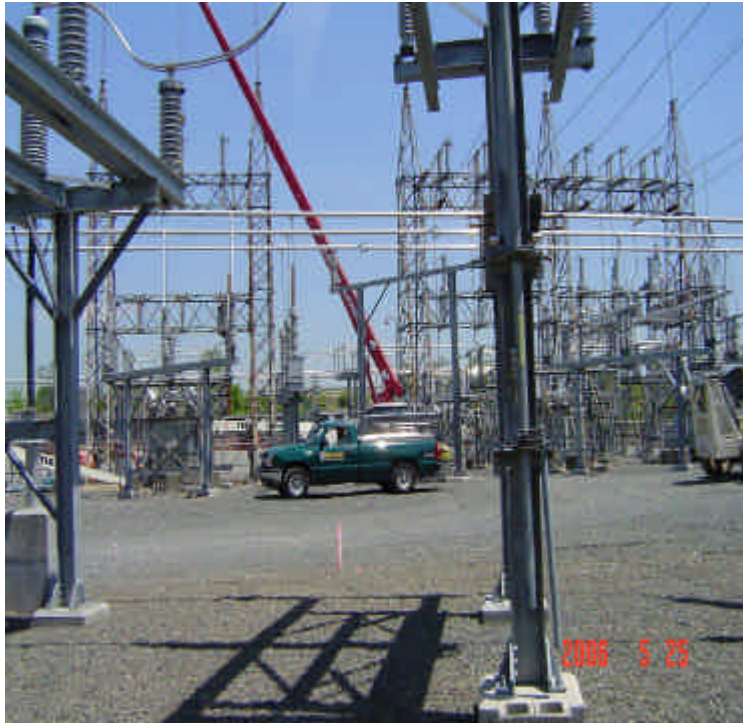
Norwalk Substation: Photo on the left shows some structural/electrical work within the yard. Photo on the right shows where the slope near the turning structure was placed with stone but some erosion was noted around the foundation of the structure. 5/25/06.

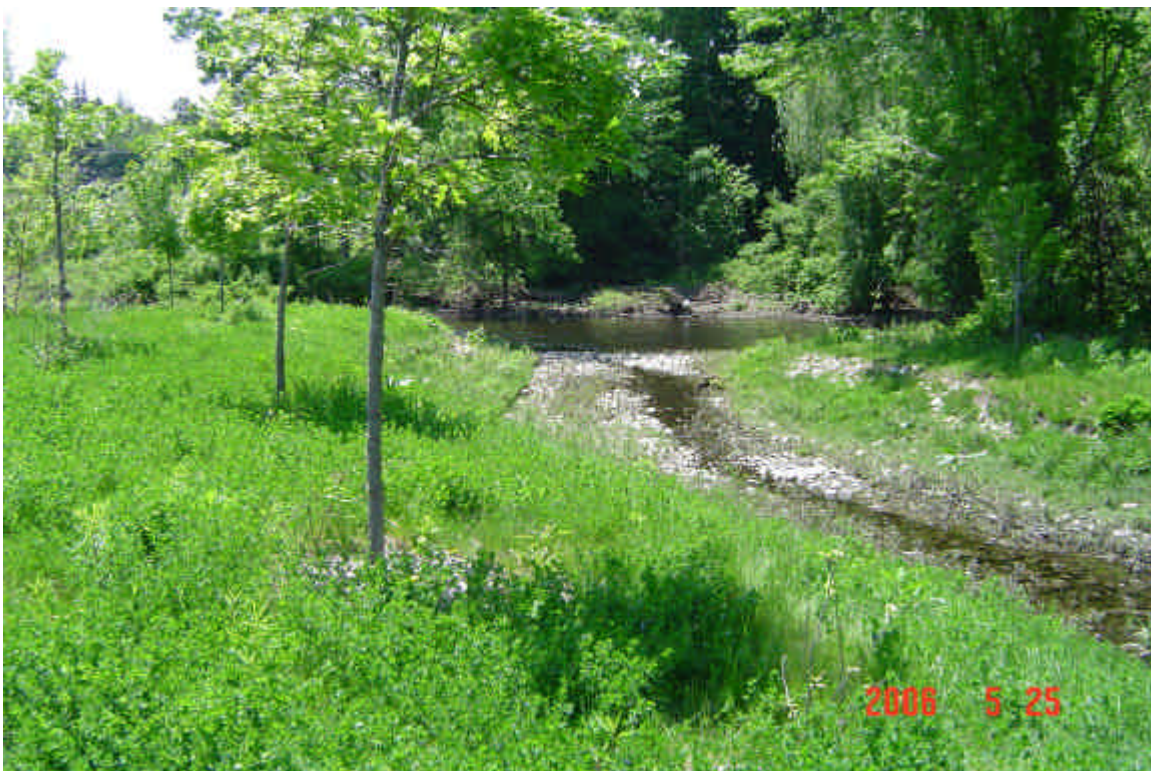
The area along the overflow channel has increasing vegetative cover and previously plantings are in good shape. 5/25/06.

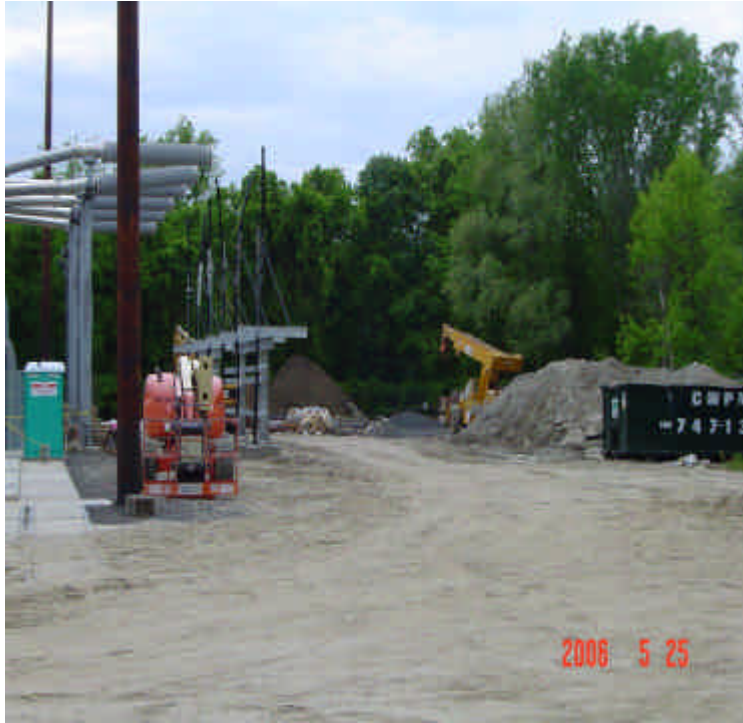
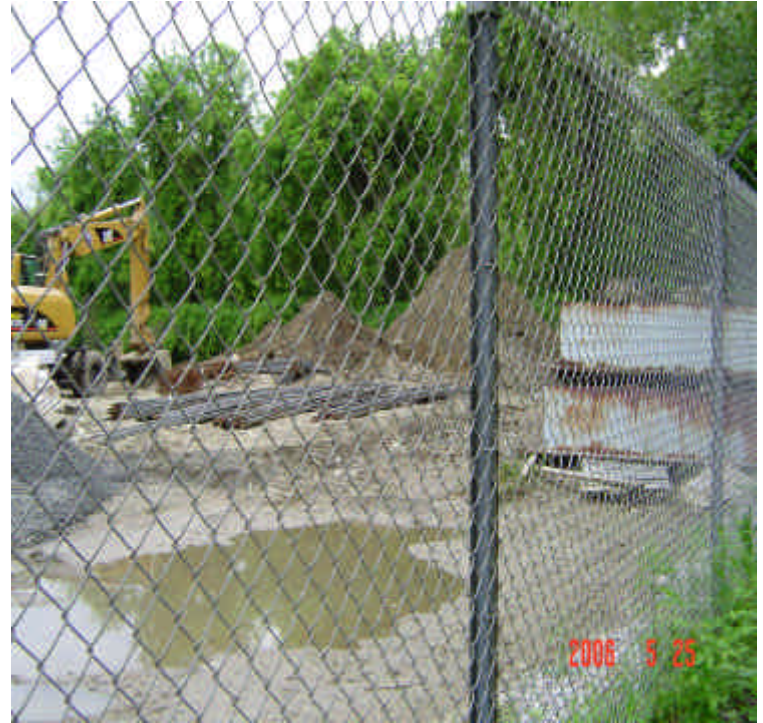
Plumtree Substation: Both photos show the ongoing foundation work and resulting stockpiles within the yard. The yard remains contained. 5/25/06.

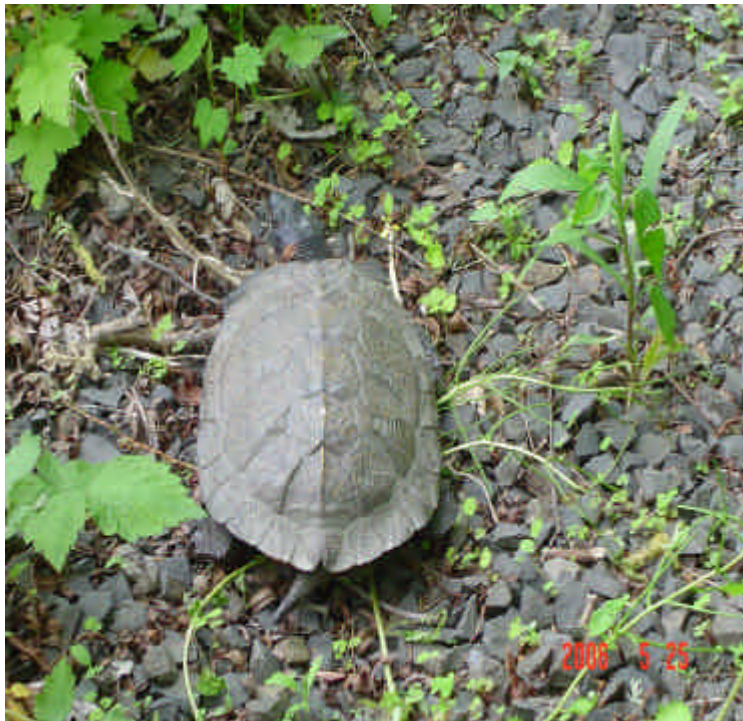
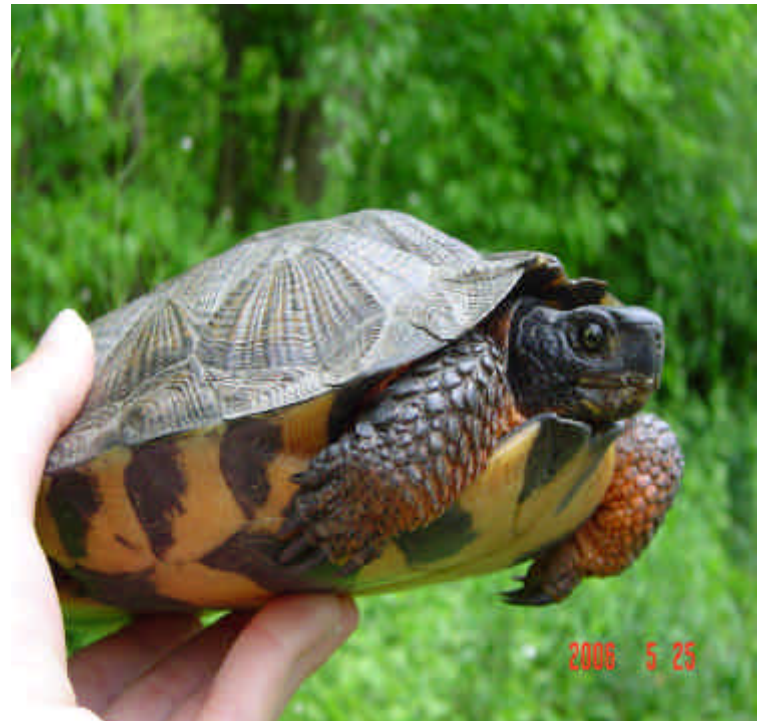
Inland Wetland and Watercourse encroachment and mitigation	- Wetlands are located around the outskirts of the substation yard.	-Continue to monitor them. Ensure that sediment does not leave the yard. 5/25/06.	N/A.
State species of concern, threatened and endangered species	- The wood turtle was noted walking along the outside perimeter of the station, along the chain link fence. 5/25/06	- Move machinery carefully and perform daily walkdowns of the site. Watch carefully for the turtle as this is the	-Daily walkdowns should be occurring at this point with crews remaining aware of machinery

Both photos show the wood turtle which was noted outside of the substation yard along the perimeter chain link fence. Crews should remain vigilant when working on or near site. 5/25/06

Areas of Inspection	Observation	Recommended Action	Corrected Action
		most active time of year. 5/25/06.	and open trenches throughout the day.
Vegetative clearing limits (including trees to save or danger trees noted)	- No vegetation outside of the substation yard will need to be cleared during the expansion work.	- N/A	-N/A
Dewatering	- Active dewatering was not observed at the inspection. 5/10-5/25/06.	-Conditions were drying out on site with the berm keeping things contained. Continue to monitor and restore controls if necessary. 5/25/06.	-N/A
Blasting	- No blasting is occurring on site at this time.	- None at this time.	-N/A
Spills and Material Storage	- No spills or leaks were noted. Now that machinery has returned, continue to monitor. 5/25/06	- The contractors should remain vigilant about securing and handling fuel containers. - Keep all vehicles maintained well (i.e. no apparent fluid leaks) if they will be used or stored on site. Check equipment status on a regular basis. - Report spills to the office immediately, even if they are being controlled.	-N/A
